20) Dinorwic Quarries and the old villages

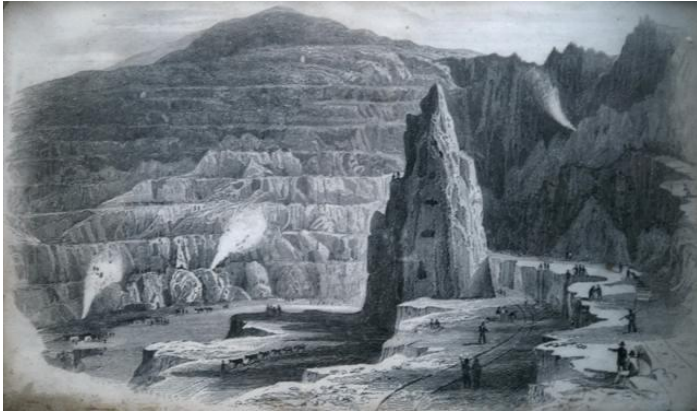
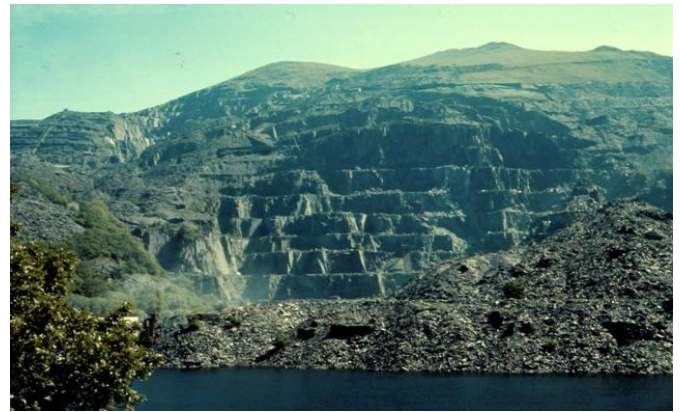
The main workings of the Dinorwic Slate Quarries themselves covered an area exceeding one square mile, fronting onto the whole length of the northern shore of Llyn Peris and reaching up the slopes of Elidir Fawr almost as far as the eye can see, to a height of over 2,200 ft above sea level. These two views contrast the quarry in around 1860 (left) with steam power evidently already in use (for driving rock drills), and (right) on the day the workings finally closed down in 1969, seen from across Llyn Peris.....

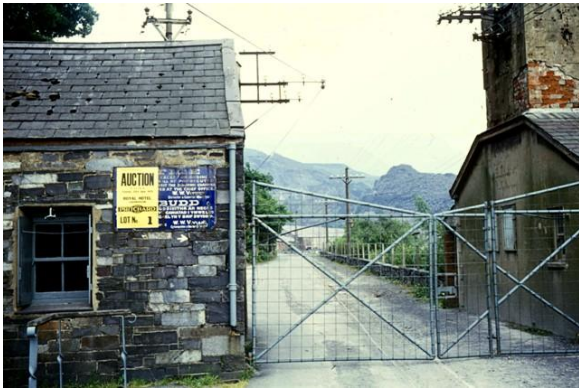
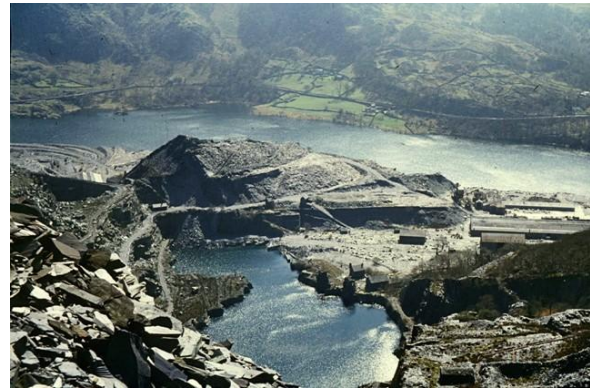
In the main quarry, the principal dressing sheds were situated in a vast complex on the shore of Llyn Peris known as Wellington Mills (591596) but this has largely been demolished to make way for the contractor's huts of the Dinorwic pumped-storage power station scheme. These first two pictures were taken looking into the area prior to this work starting.....

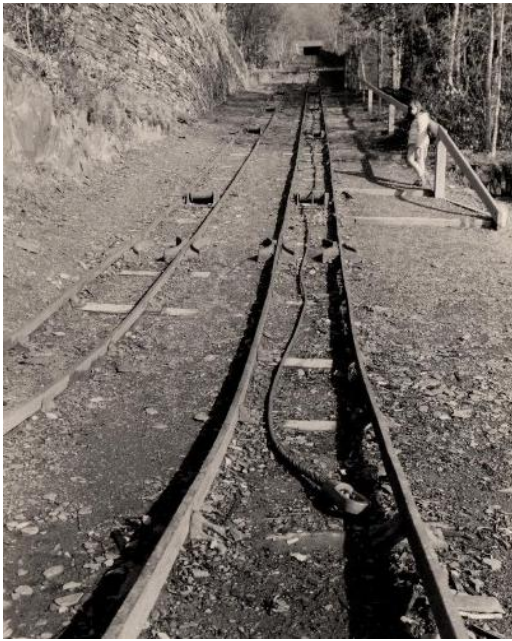
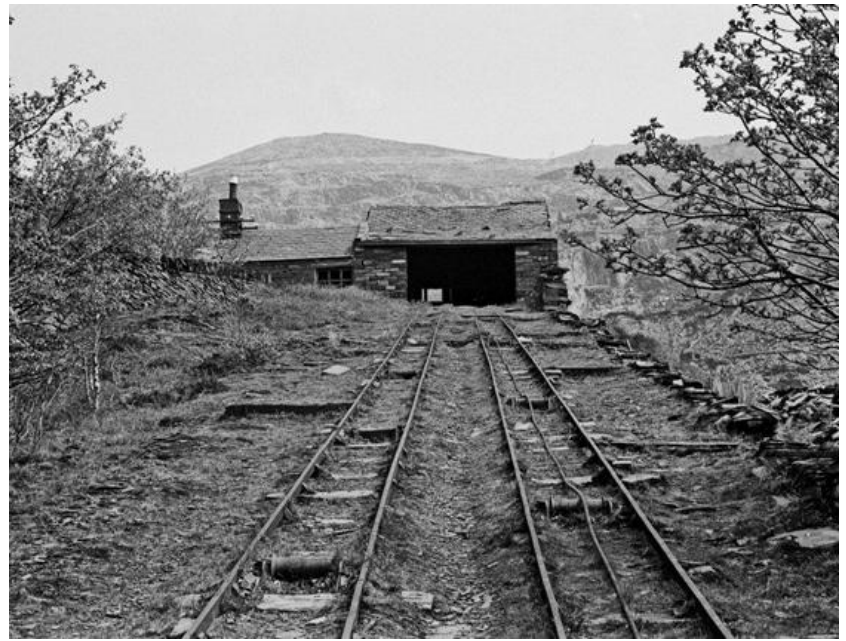
From the main quarry and country park entrance between the two lakes a public footpath, formerly the "zigzag path" built for the convenience of quarry workmen, leads right through the west side workings and provides easy access for limited exploration at various points. After an initial steep section, the path crosses the main railway "A" inclines coming up from the workshop area by the second drum house. These are largely intact with all equipment and rail tracks, and may eventually be restored as an operational exhibit by the museum authorities. Our pictures show (left, by David Mills) the full extent of the A1 incline, and (right) the top part of A2, with its drum house and adjacent "caban" (staff mess room) to its left.....

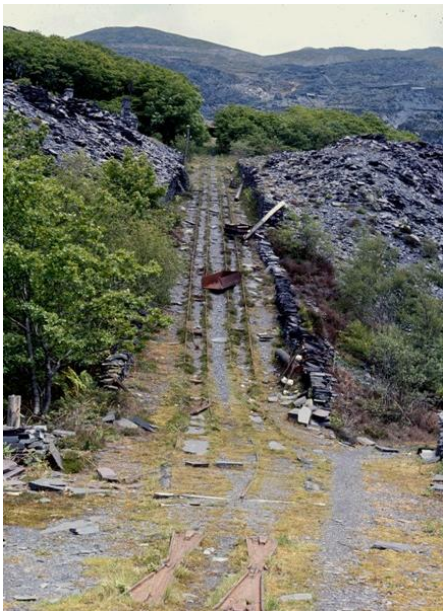
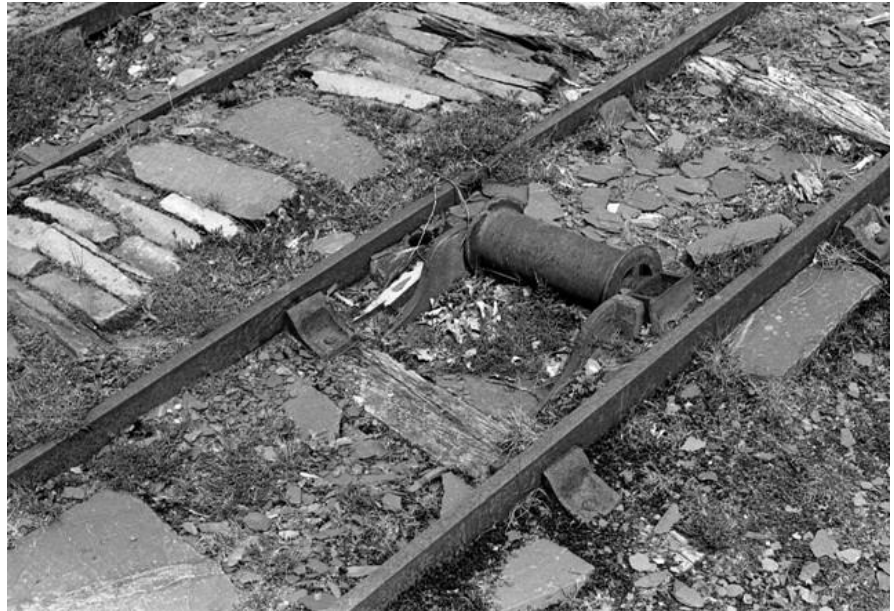
The level here may be followed eastwards round to the foot of, then up the third and fourth inclines, which are also well preserved, if desired; a good impression of the sheer scale of the quarry workings may be obtained by so doing. Here are two views on these inclines, with detail of the track – simple flat iron bars in special chairs nailed to wooden sleepers – and the rollers which guided the haulage cable.....

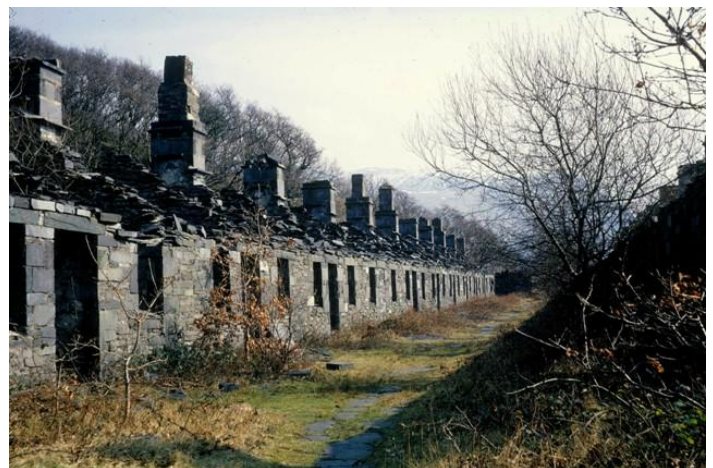
The public path meanwhile continues up the hillside and shortly passes a double row of roofless cottages on the right hand side (589603, picture right; the row may also be entered at the opposite end, from half way up the third incline).

These were the quarrymen's barracks where those employees living further afield such as Anglesey spent the weeknights, returning home only at weekends. Called "Dre Newydd" (New Town) these were specially built to accommodate such workmen, in conditions which although hideous to modern eyes were probably little worse than those prevailing in some of their homes at this time. Rendered long derelict by improved means of transport, the "street" is now due for restoration as a museum piece.

The “**Anglesey**” **barracks** have also been conserved, though remaining largely in ruinous state. The **Steam Mills** site is also ruinous, with most ferrous material long since removed for scrap.

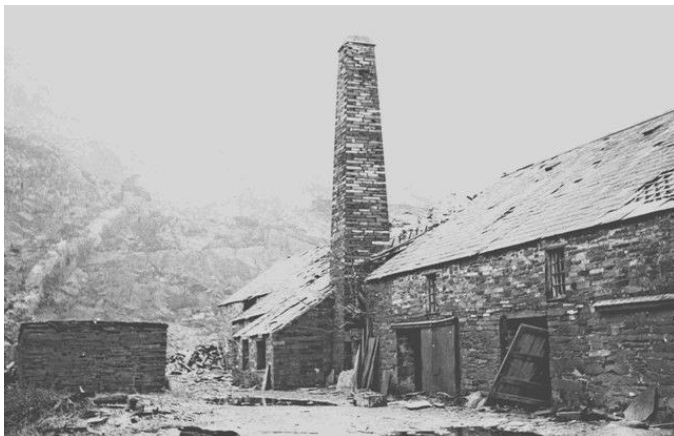
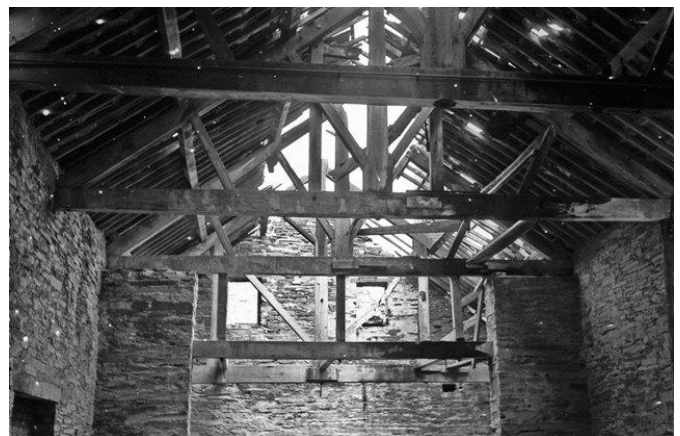
The first large building, now derelict and stripped of all reusable timber and slates, was the Village Mills, a later mechanization of the dressing processes which used all-electric power: the substation is adjacent. Just around the corner, also regrettably stripped but still identifiable by the large slate slab chimney stack, are the Steam Mills (594606), built in 1847 and noteworthy as representing the first application of steam power to slate dressing. The original machinery, well documented in the contemporary press as the herald of a new era in North Wales, has long since been removed. The buildings, tended carefully by the quarry concern well after they ceased to serve their intended purpose, now bear the open wounds of recent indiscriminate destruction resulting from the proximity of the power station project; their significance it seems has now been totally forgotten (pictures below).....

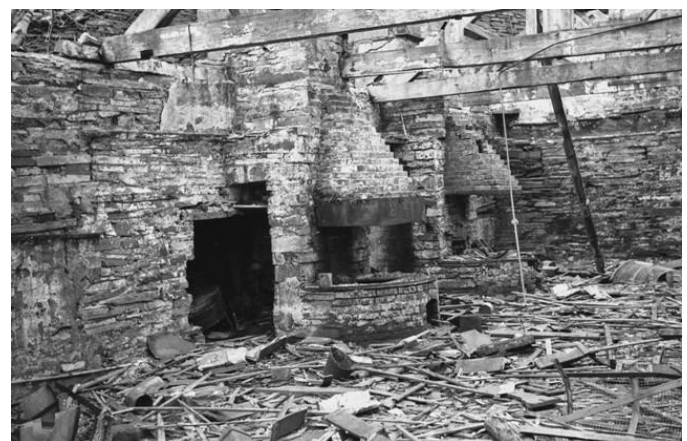
The group of buildings opposite the Steam Mills comprised foundry (picture right), stores, workshops, canteen and pay office. Although all of these have similarly been vandalized over the last two or three years, most were still in active use up to the end of the quarry operations in 1969. From this major intermediate level, the inclines continue their unrelenting ascent skywards into the mist, but the topmost levels at something over 2,000 ft may be more easily reached if desired via another of the old workmen’s access roads at (594613).

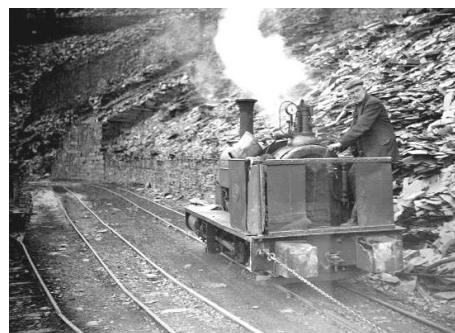
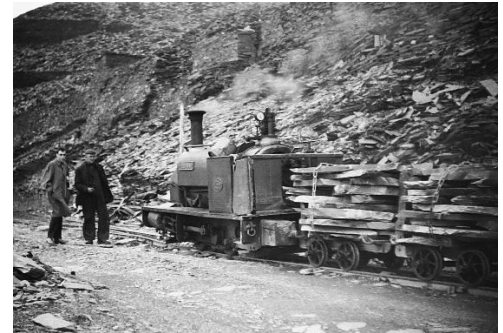
Here is a reminder of the very last steam locomotive to work in the quarries, on Twllwndwr level (about 6 down from the top on this side), “Holy War” in 1967 (b&w) and summer 1968 (colour). We enjoyed several sessions with the driver here

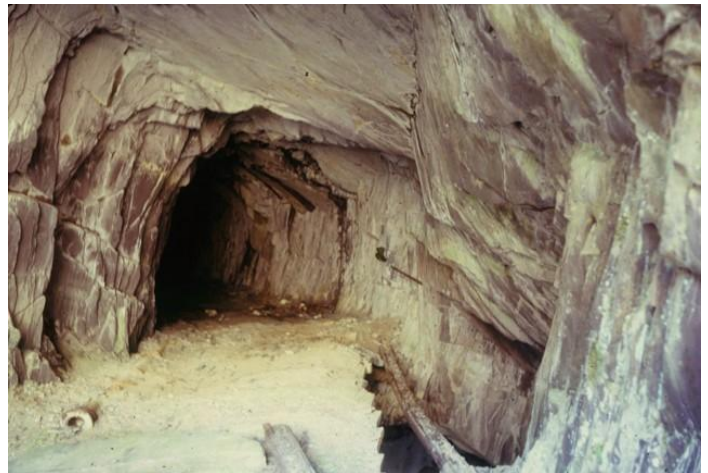
The early workings are a jumble of levels, tips, inclines and tunnels (photo right; this was as far as we dared venture, as the "bridge" in the foreground over a deep chasm looked to be of questionable integrity!)

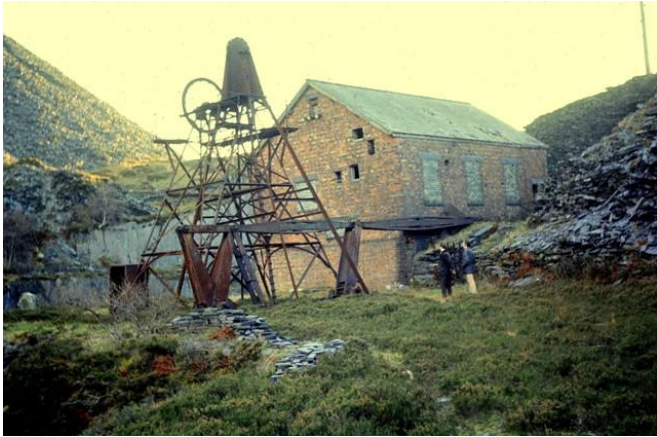
This situation resulted from the haphazard amalgamation of separate small enterprises started by individual quarrymen. Despite these problems, long since eliminated in the main quarry, some parts continued to be operated until comparatively recently. Some of the more interesting non-standard features have however regrettably disappeared since closure: the large winding and pumping engine at Allt-Ddu pit (left below), with massive wooden beams driving the pumps; and the unusual 4 ft-gauge side-loading transporter incline at Brynlllys (588612, right).

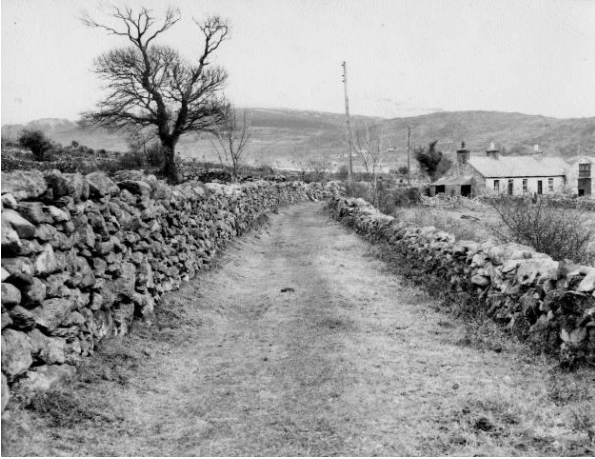
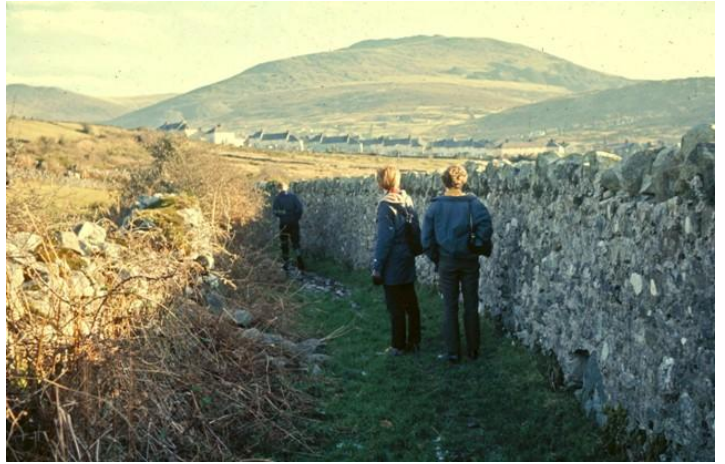
Here are some other views along the route of the 1824-43 Dinorwic tramway, the first two on a very well preserved stretch at Clwt y Bont, to the south and west of Deiniolen village.....

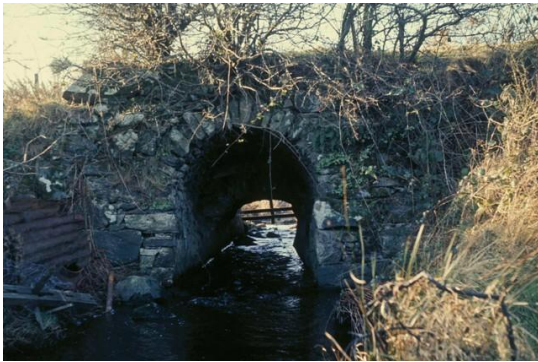
This little stone bridge under the tramway (below left) was near Ynys Llech Arian, adjacent to the main road but now obliterated by widening and straightening work on the latter. Nearby we found this discarded broken cast-iron sill (sleeper) from the tramway track, uncovered during excavations for drainage pipes in connection with the road work; it is now in the Penrhyn Castle museum.....

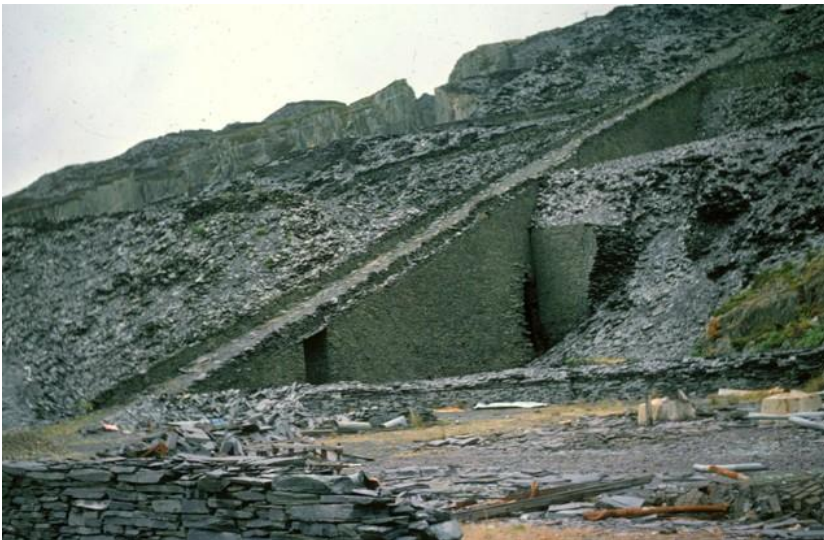
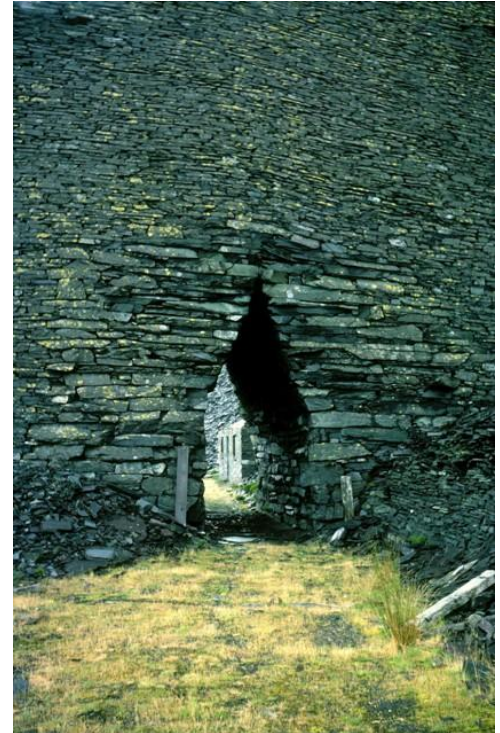
Some idea of the volume of traffic handled from here is given by this incline, which had to be quadrupled on its lower sections circa 1900 to cope with the loadings from the dressing sheds. The main east side inclines (now trackless) recommence their ascent from Dyffryn Mills level on a colossal dry slab-wall construction, in parts over 50 ft high and pierced by characteristic pointed arches to accommodate the main level tramway tracks.....

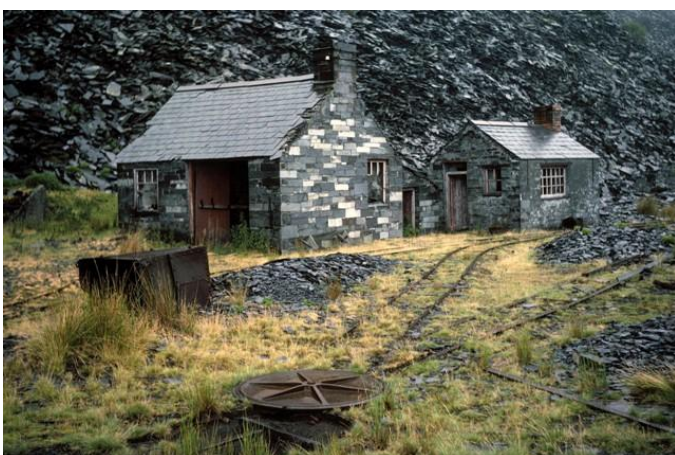
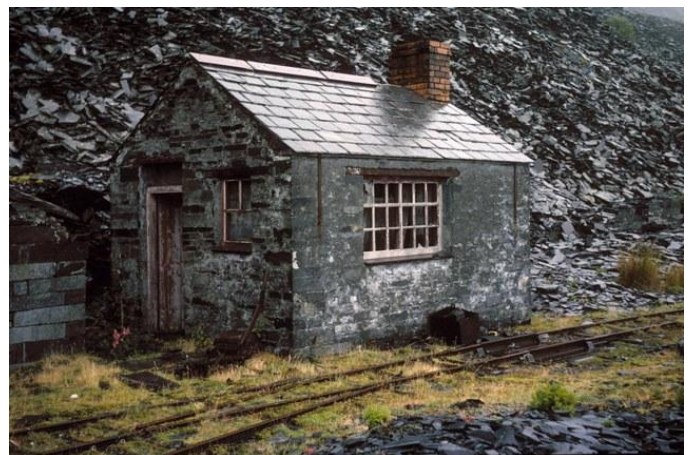
Rails-in-situ commence just below the summit drum house of this remarkable incline and they are intact in most of the workings beyond this point. 3” x 1” steel bar rails slotted into the wooden sleepers or held in crude iron chairs are used for the inclines and other sections not traversed by steam locomotives, whereas the “main line” on each working level and out onto the waste tips is in a heavier bullhead section in conventional chairs with wooden keys. The winding drum house is complete with drum, cable and brake assembly; the operator’s caban with stove, cupboards and benches is adjacent. The name of this level was “Ponc Roller”. The tracks divide left and right to the working face and tips, there is a shed for a diesel locomotive and a weighing machine (pictures below) over which the wagons of waste rock passed, for even the latter had to be assessed and accounted for!.....

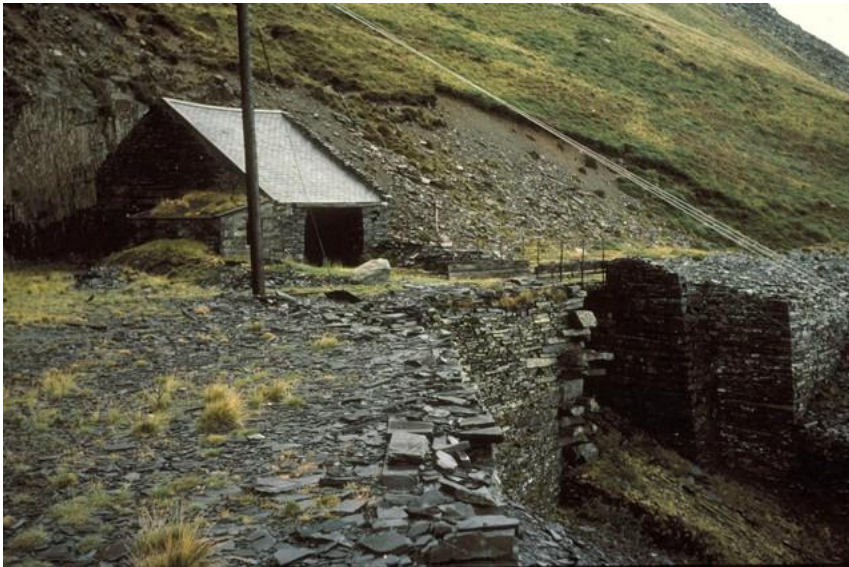
Straight ahead is a further gravity incline which ascends past several more levels and beneath a bridge before terminating abruptly at the sheer rock face behind the “Australia” level drum house. The ingenious

arrangement for balancing the incline when accepting wagons off the spur lines coming in from the intermediate levels may still be studied on this particular example, since most of the apparatus has remained undisturbed after closure. "Australia" was an important level, and most of its buildings also survive relatively intact. Empty wagons arriving at the incline head turned left via a wagon turntable to enter the dressing mill, and from here a track also leads back over the bridge just mentioned, then on to the waste tips. This curious arrangement not found elsewhere in the quarry was necessitated by the acute lack of space at the summit of the incline.....

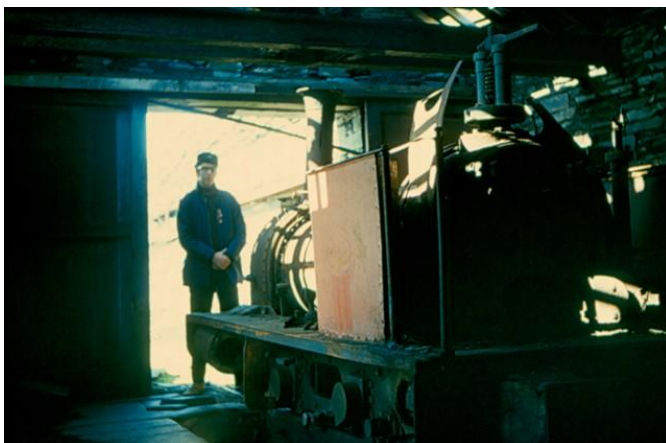
Here are the mortal remains still in the shed in 1970; against all expectations it was laboriously brought down the inclines and taken away for preservation a few years later, as seen here.....

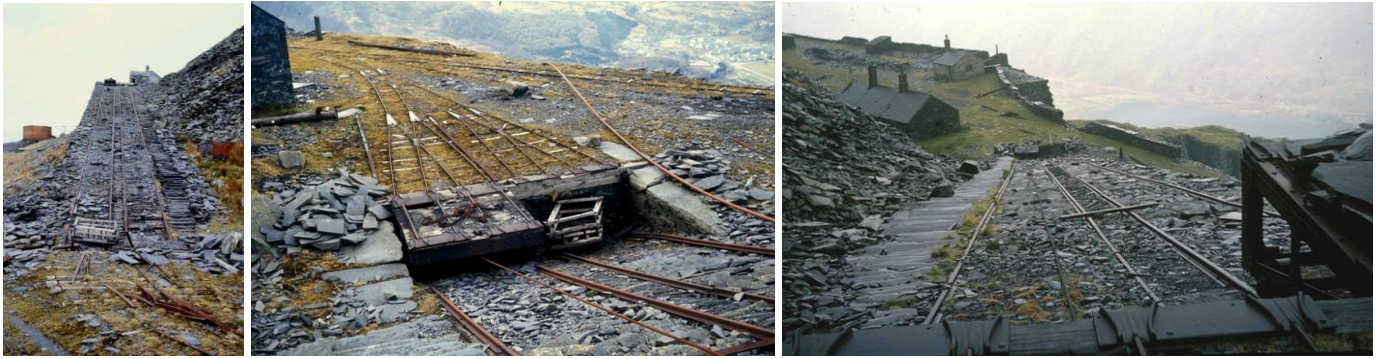
Beyond, an incline leads off upwards yet again to a further set of levels which were once joined to those on the west side (it is thereby but a short step from Australia to Egypt!). This incline and the one above it are

of the transporter type with carriers running on 7 ft gauge tracks but were gravity operated, unlike similar ones in the lower quarry pits which had to be water-balanced in order to raise loaded trucks.....

The “ships wheel” operating the ratchet brake was used to control the working of the incline, from the hut at the summit. The level here was called Egypt, or in Welsh “Aifft”, and the one above it Panwrs, where there are several of the old wooden-bodied slate trams in the vicinity of the transporter. Yet another incline heads upwards to terminate at the topmost level once traversed by a steam engine, “Lernion”, whose shed could boast of being the highest locomotive depot in the United Kingdom at 1,860 ft above sea level. Beyond is the virgin grass of Elidir Fawr, punctuated by only a few short-lived trial levels; here the quarrymen finally gave way to sheep.

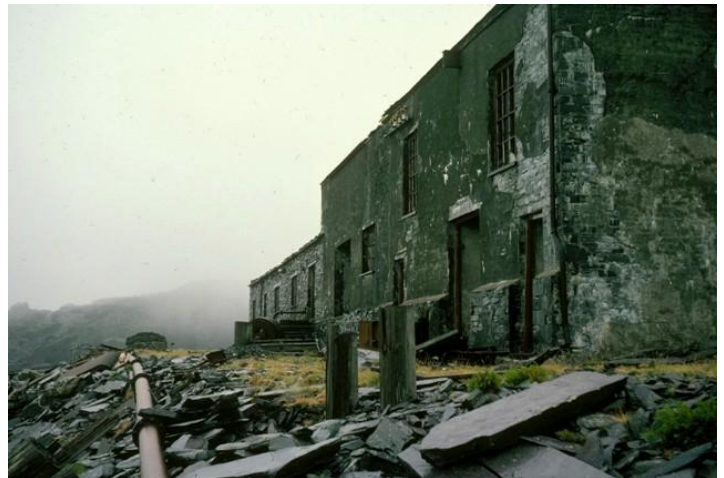
Beside the foot of the Australia - Egypt transporter incline is a large building (picture right) housing two giant air compressors, which supplied power for rock drills throughout this side of the quarry. One is a vertical compound machine, the other a two-cylinder Ingersoll-Rand horizontal simple; both these were electrically driven by large motors. The main gallery tramroad leads past this building to terminate in the debris and sheer rock-face left by the disastrous 1961 rock fall. This effectively spelt the end for this section of the workings, which became quite inaccessible by even the roughest of quarry roads. One might wonder how they ever managed to get the compressors up here, and whether the scrap dealers will ever find it worth their while to get them down again.

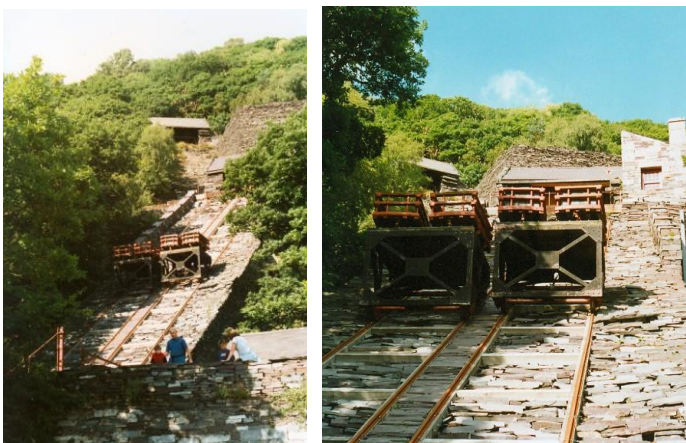
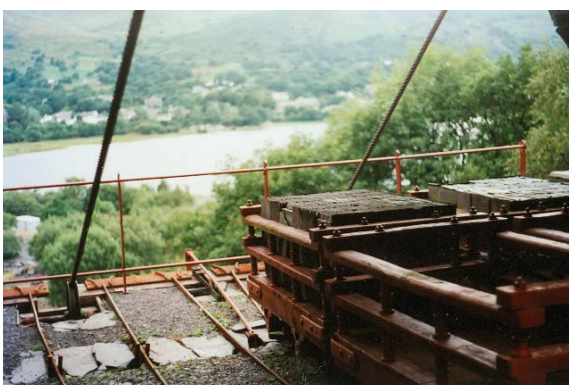
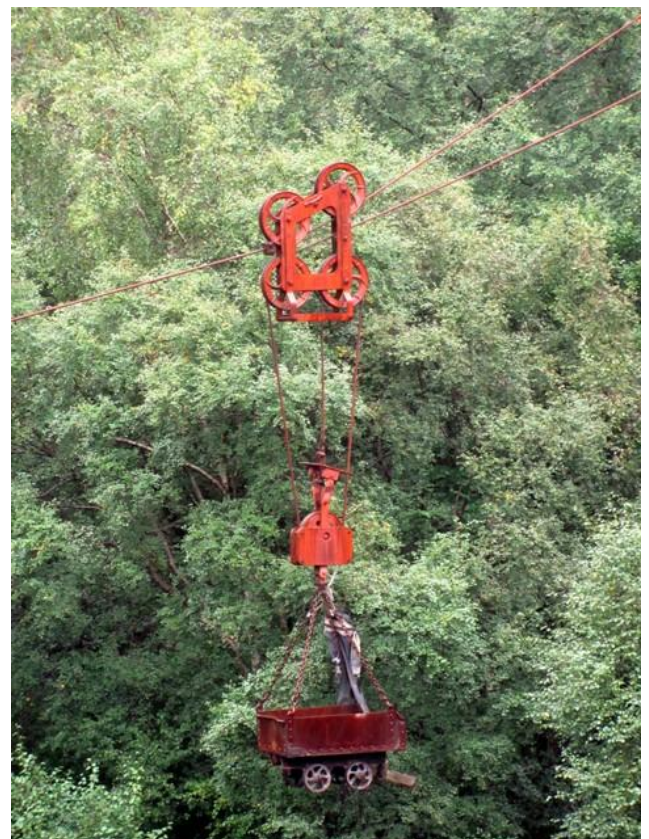
The lower section of the Vivian Quarry **transporter incline** has been restored to full working order, and is demonstrated from time to time (below). There is also a surviving Blondin suspended over the main pit....
